Latch correction on camping equipment

Rework services

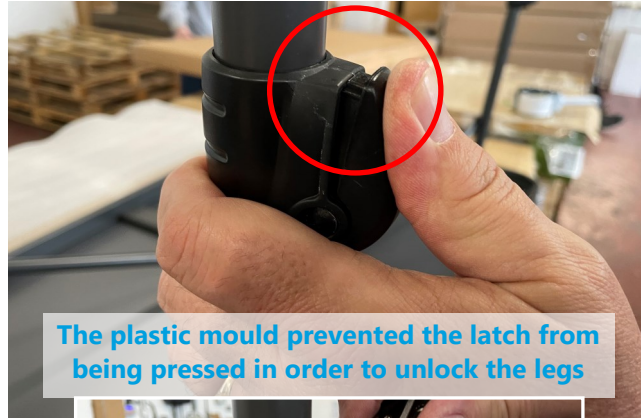
The plastic mould prevented the latch from being pressed in order to unlock the legs
